In-stream Remediation of a Hydrocarbon Release in North Central Alberta, Canada

Wayne Wiebe, A.Sc.T., CCEP
General Manager

May 2-4, 2006

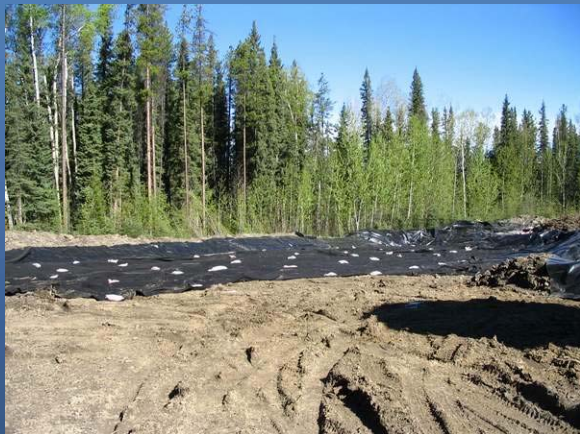
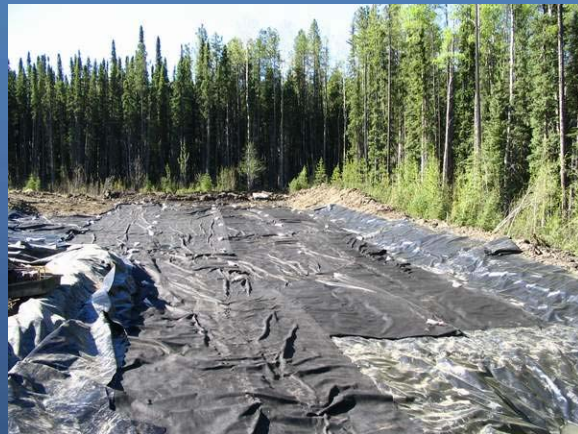
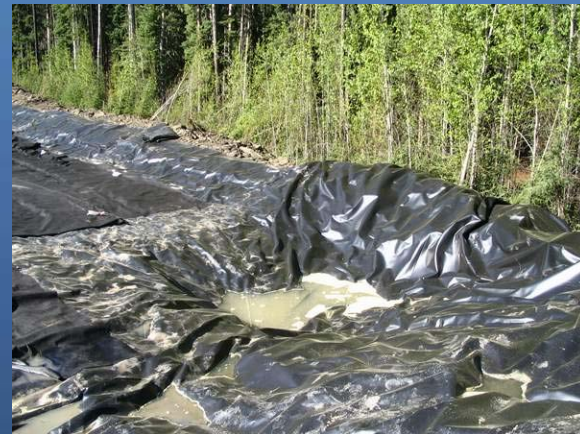
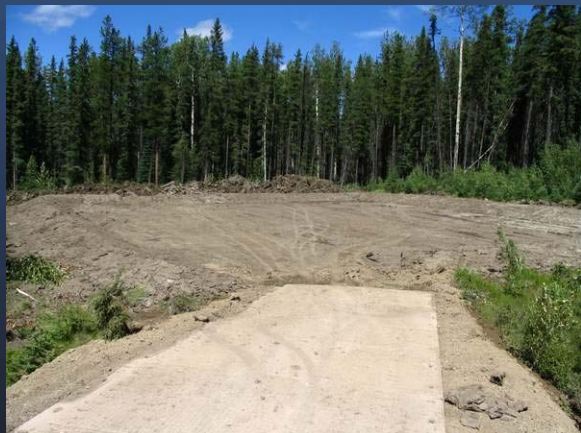
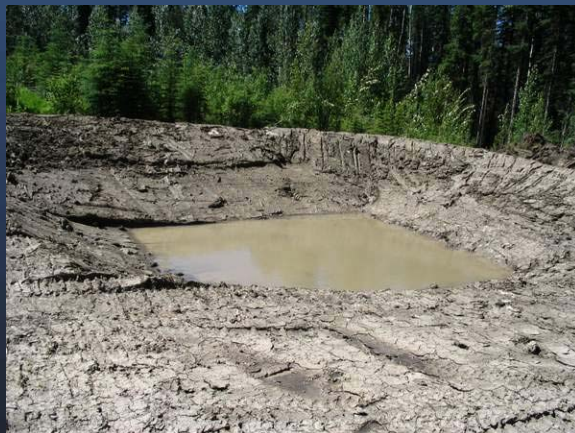
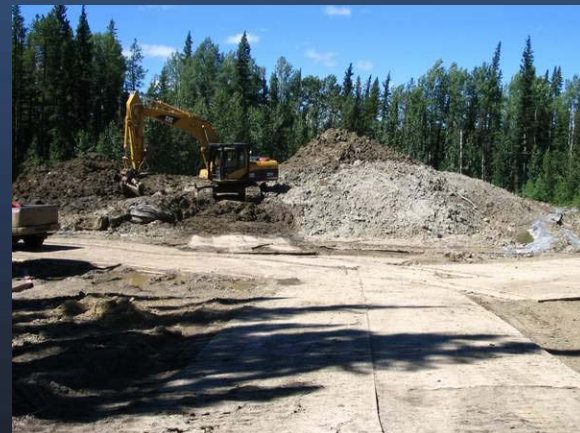
Treatment Area Construction

- Two treatment cells constructed at an adjacent inactive oil wellsite
- To ensure proper containment, clayey backfill material was placed and compacted at the base and on the berms of the treatment cells
- To contain fluids and prevent contaminant migration, berms with a height of approximately 4 ft were constructed around the treatment cells
- Each treatment cell was contoured to allow for drainage toward a leachate collection area
- The treatment cells were lined with a 30 mil Enviro-Liner

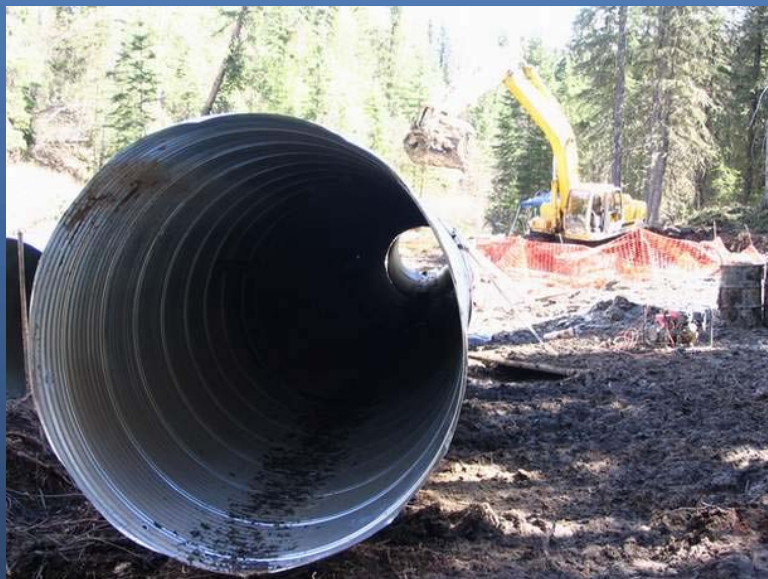
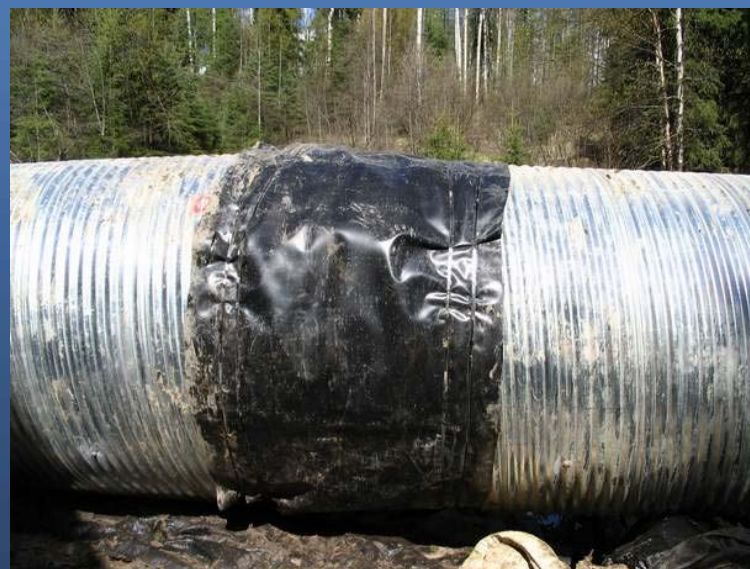
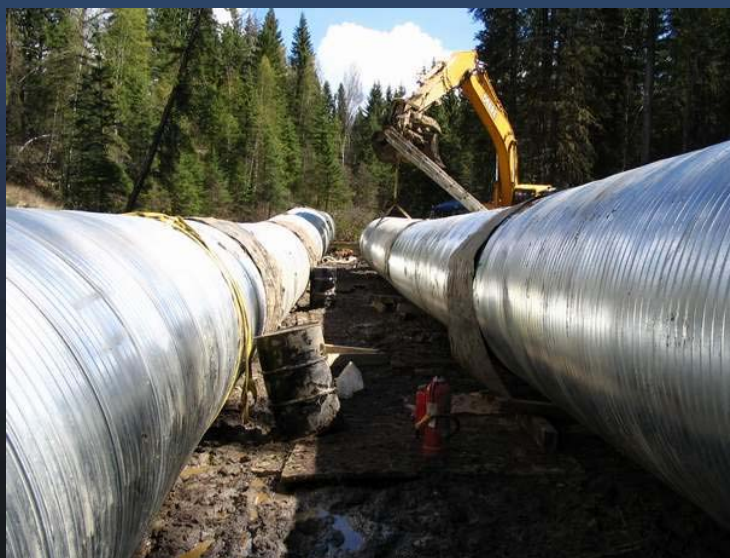
Diversion Flume Construction

- The flume consisted of two steel culverts 6.5 ft in diameter and 118 ft in length fastened together and moved into place using excavators
- To direct water from the stream into the flume, and to prevent backflow from the downstream portion, two diversion walls were constructed
- The diversion walls consisted of concrete blocks (Jersey blocks) installed on a prepared (levelled) portion of the stream
- A 30 mil Enviro-Liner weighted with bulk sand bags was used to seal the diversion walls

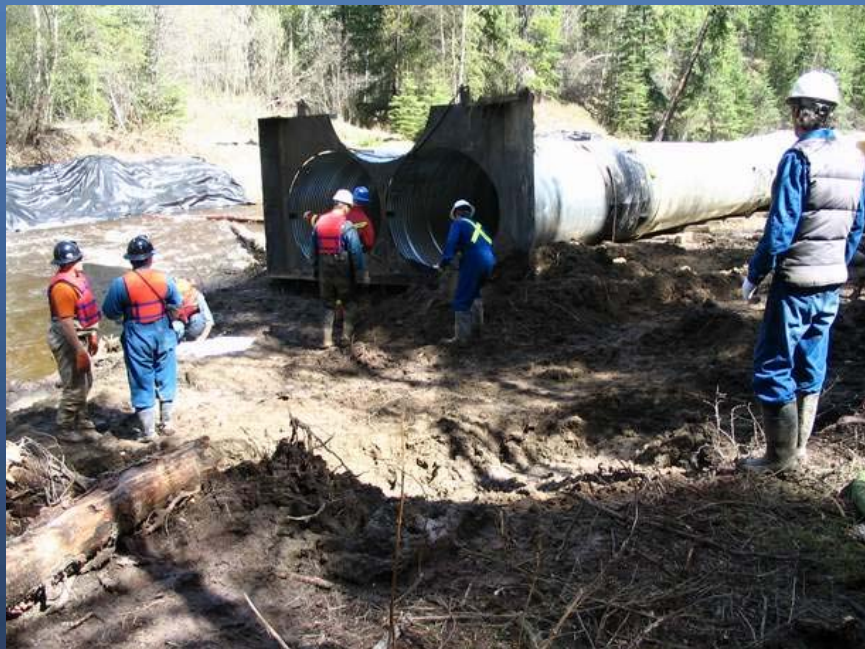
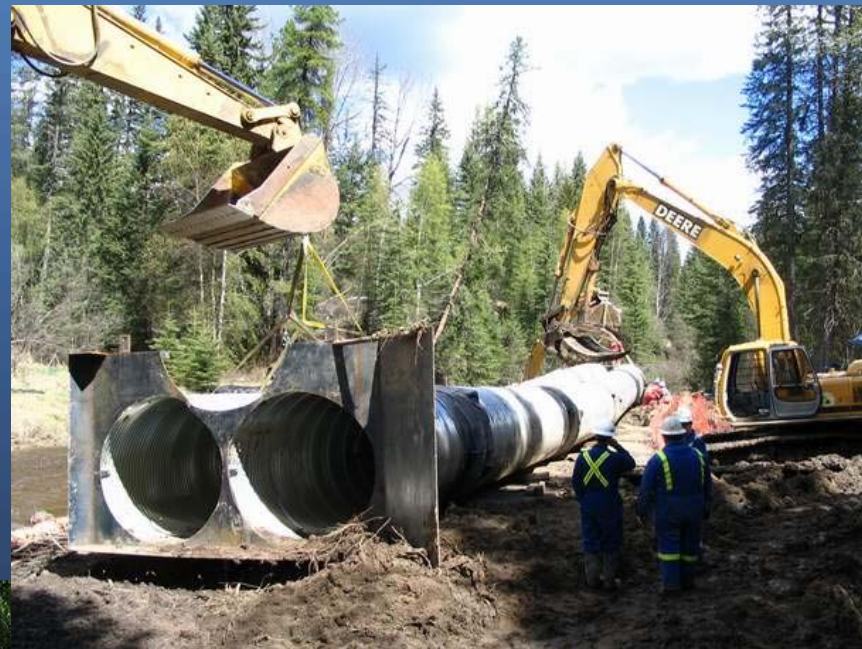
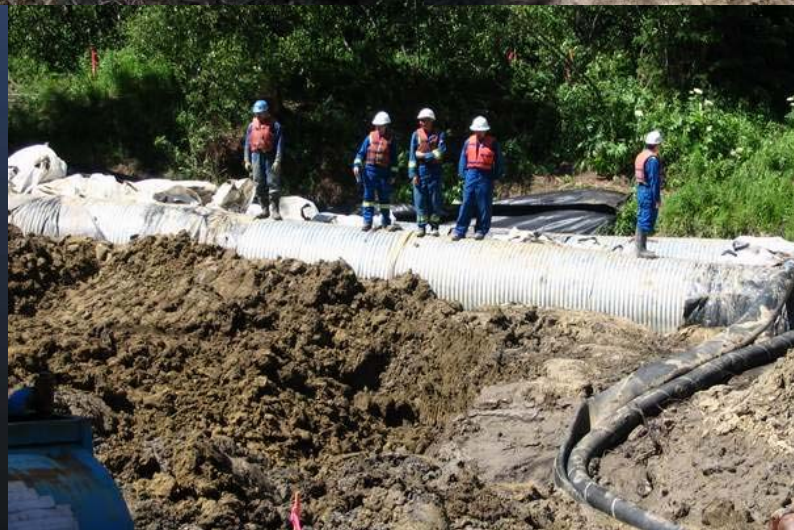
Diversion Flume Installation

- To prevent bank erosion and stream siltation, the north bank of the stream along the intake and the discharge portion of the flume were lined with woven polypropylene (PP) geotextile
- Non-woven geotextile was installed at the discharge portion of the flume to prevent scouring of the river bed
- A “grey water” pit, and a series of bellholes excavated along the isolated portion of the stream bed were used to collect fugitive flow through the flume, and dewater the work area

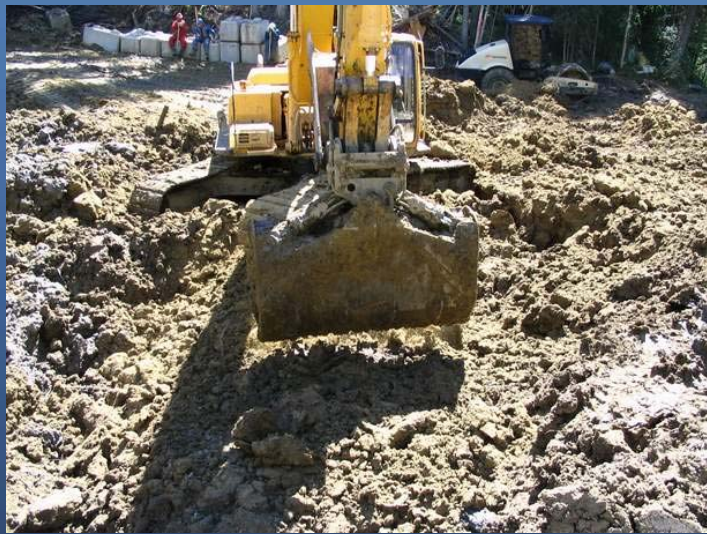
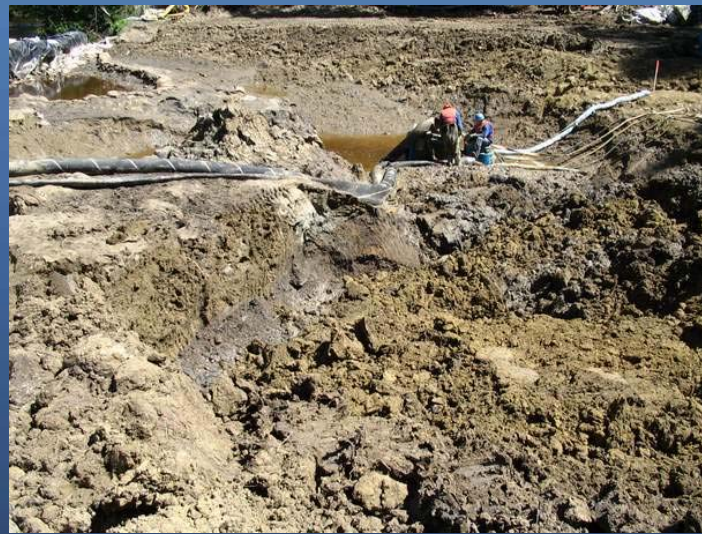
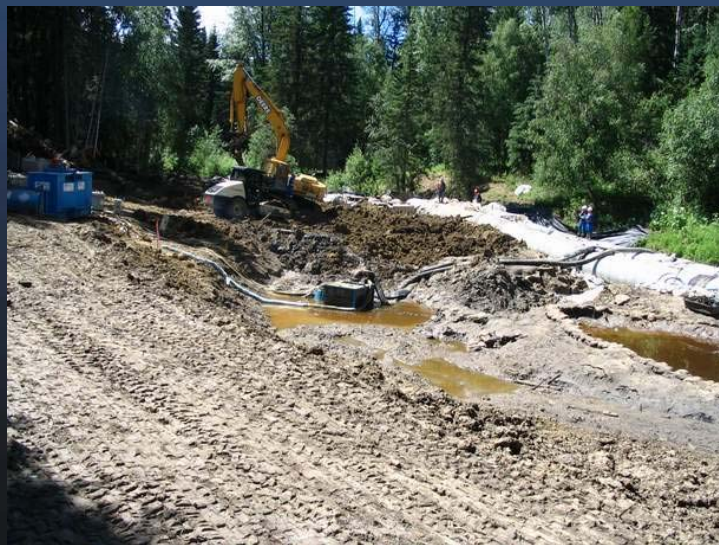
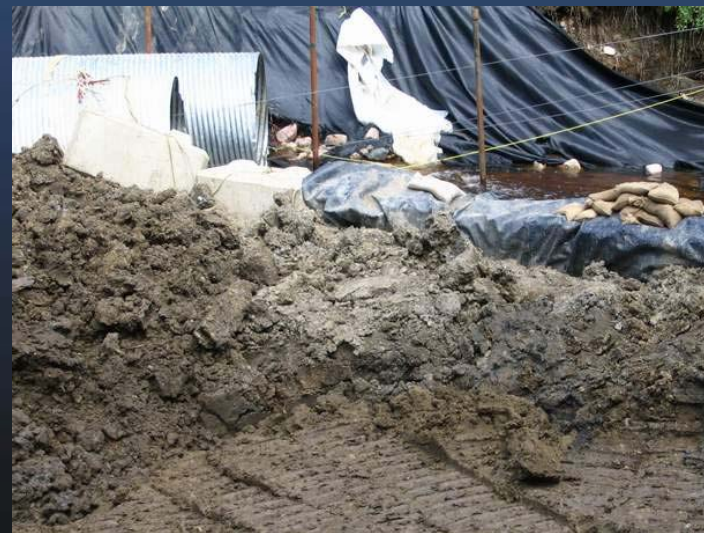
Remediation Program

- Removal of impacted material from the pipeline break point was initiated on May 07, 2005
- Excavation activities resulted in exposure of the pipeline and identification of the break point on May 11, 2005
- Removal of impacted material from the pipeline break point, and the south bank of the stream were completed on June 16, 2005

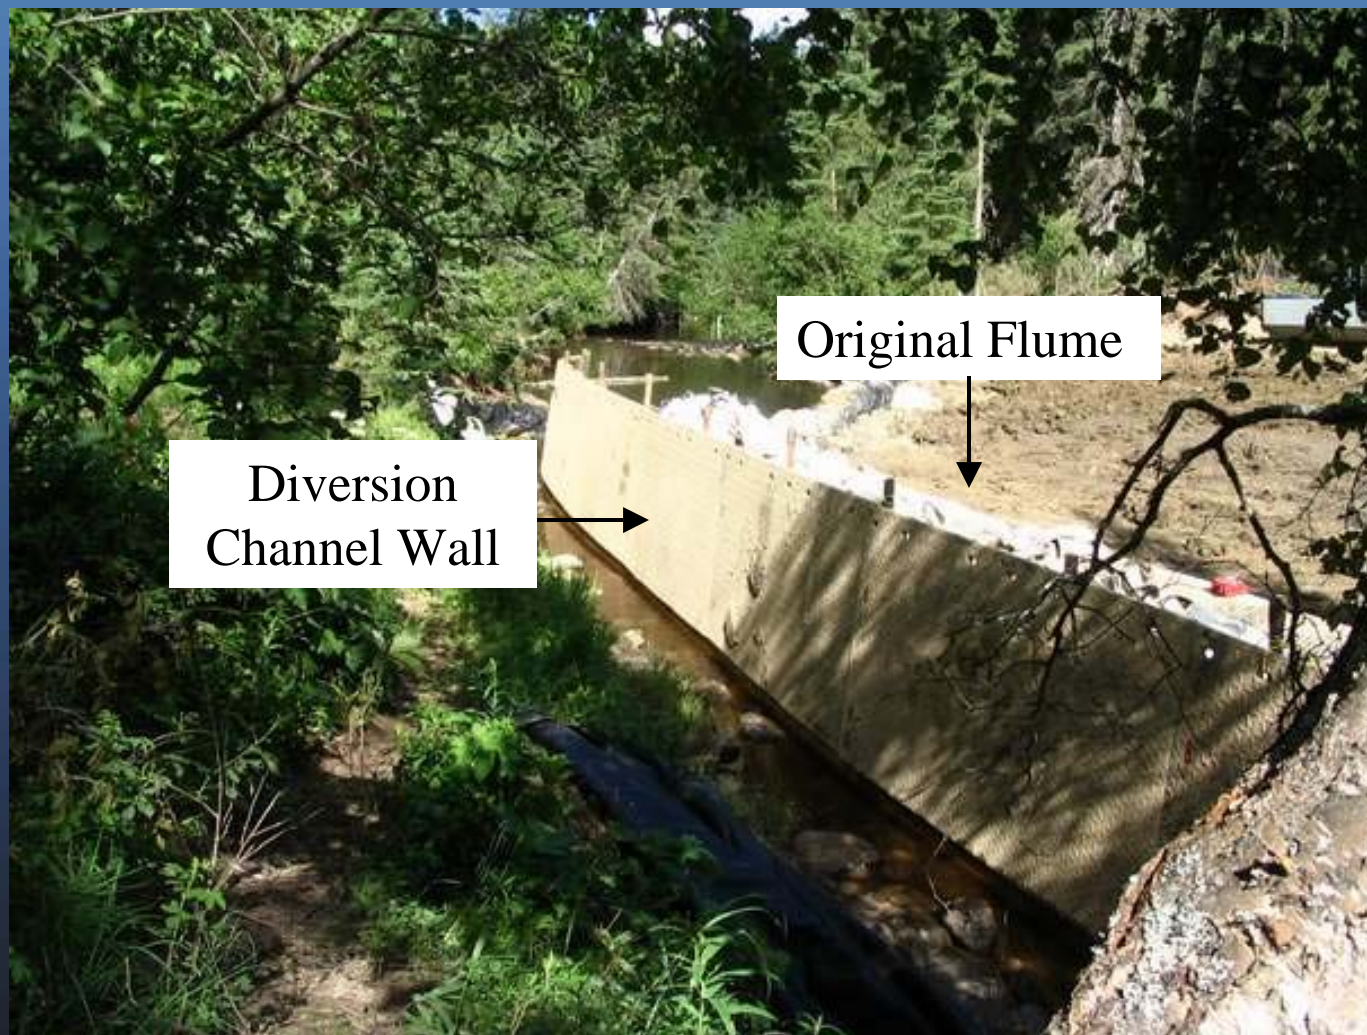
Diversion Channel

- The diversion structure consisted of swamp mats keyed together, and installed as a wall along the north bank of the stream
- Steel piping anchored into the stream bed was used to support the structure
- A 40 mil Enviro-Liner was used to seal the constructed diversion channel
- The liner anchored onto the constructed swamp mat wall and on the north bank of the stream
- The upstream diversion wall was extended and keyed into the constructed structure

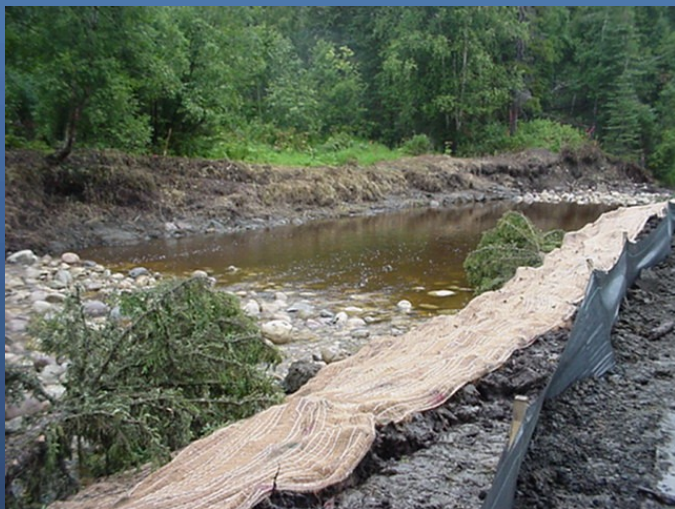
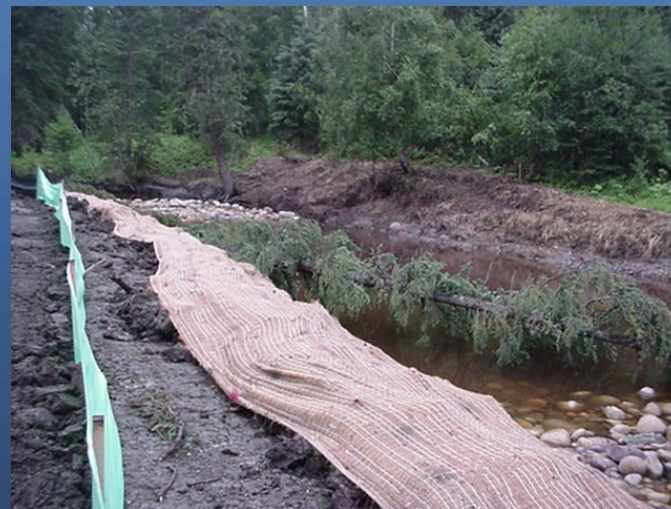
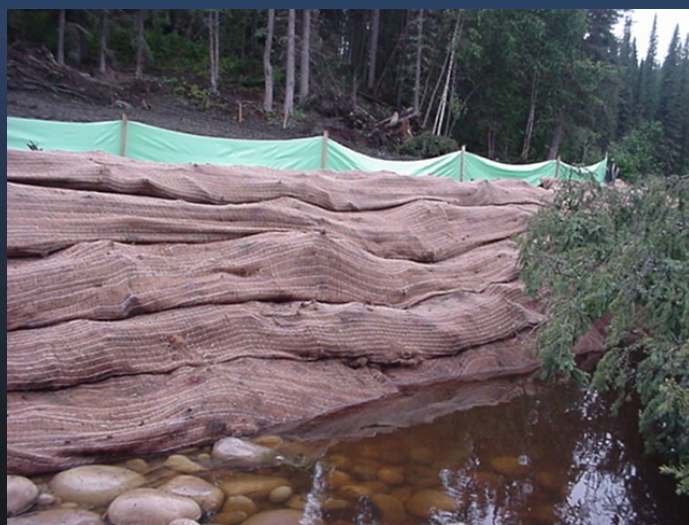
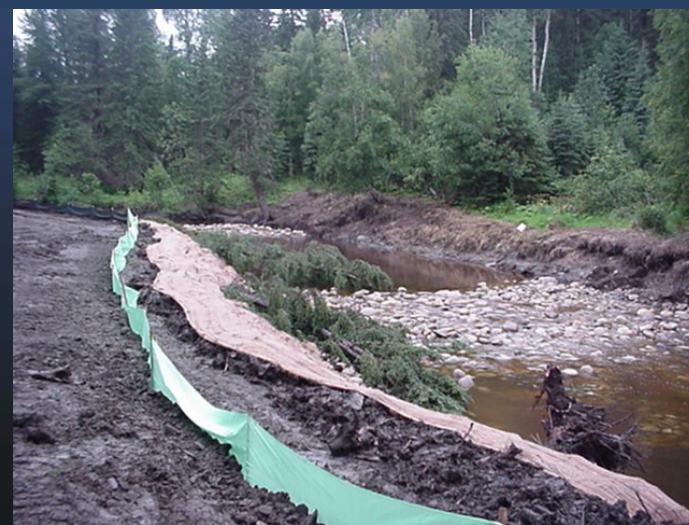
Streambed Reconstruction

- The streambed reconstruction program was initiated on Aug. 08, 2005 and completed on Aug. 11, 2005
- The program was initiated upon completing the remediation activities and removal of the stream diversion structure
- The reconstruction activities were planned and supervised by a consulting team specializing in aquatic/biological engineering
- Including re-contouring, placement of boulder and cobble rip rap, stabilization of stream banks, placement of habitat structures
